TREE REPORT

**880 S. Westlake Boulevard
PTP 2024-70020**

Date: April 24, 2024
Job No. 24-027

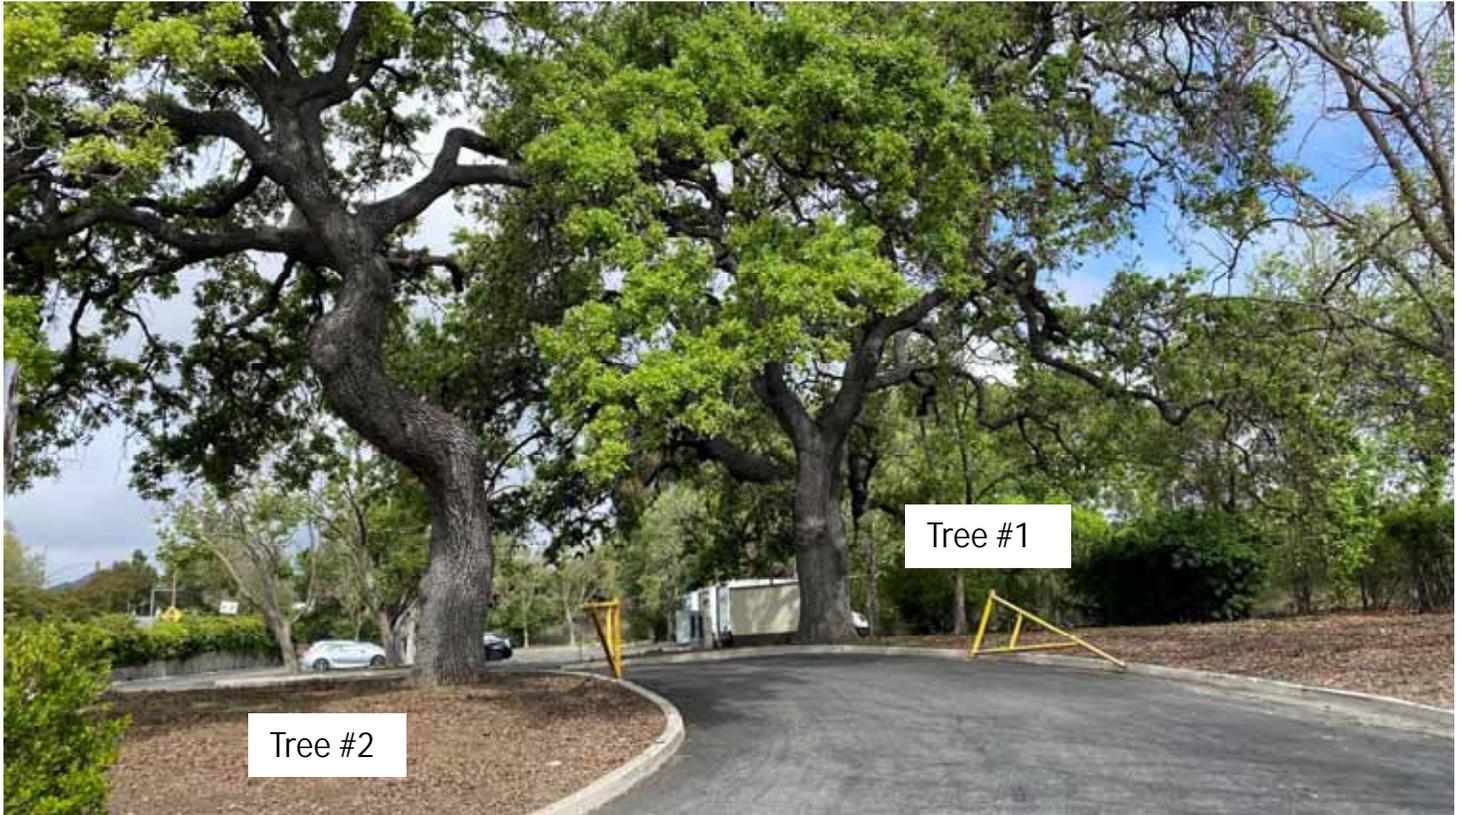
Trees #1 and #2 facing north

Pruning is recommended to raise some low branches to prevent damage from trucks during construction and when it is ready to be used to accommodate food trucks. 16 feet of clearance should be maintained over the driveway and parking lot. Tree #1 should be pruned on the northwest quadrant of the driplines by reducing several branches that are no greater than 2 inches in diameter to achieve 16 feet of clearance. Tree #2 should be pruned on the southeast quadrant over the driveway; 3 branches no greater than 3 or 4 inches in diameter should be reduced to achieve 16 feet of clearance over the driveway. No other pruning of live tissue is necessary for trees #1 and #2. There are many large and small dead branches that should be removed throughout both trees to prevent them from causing damage or injury when they fall.

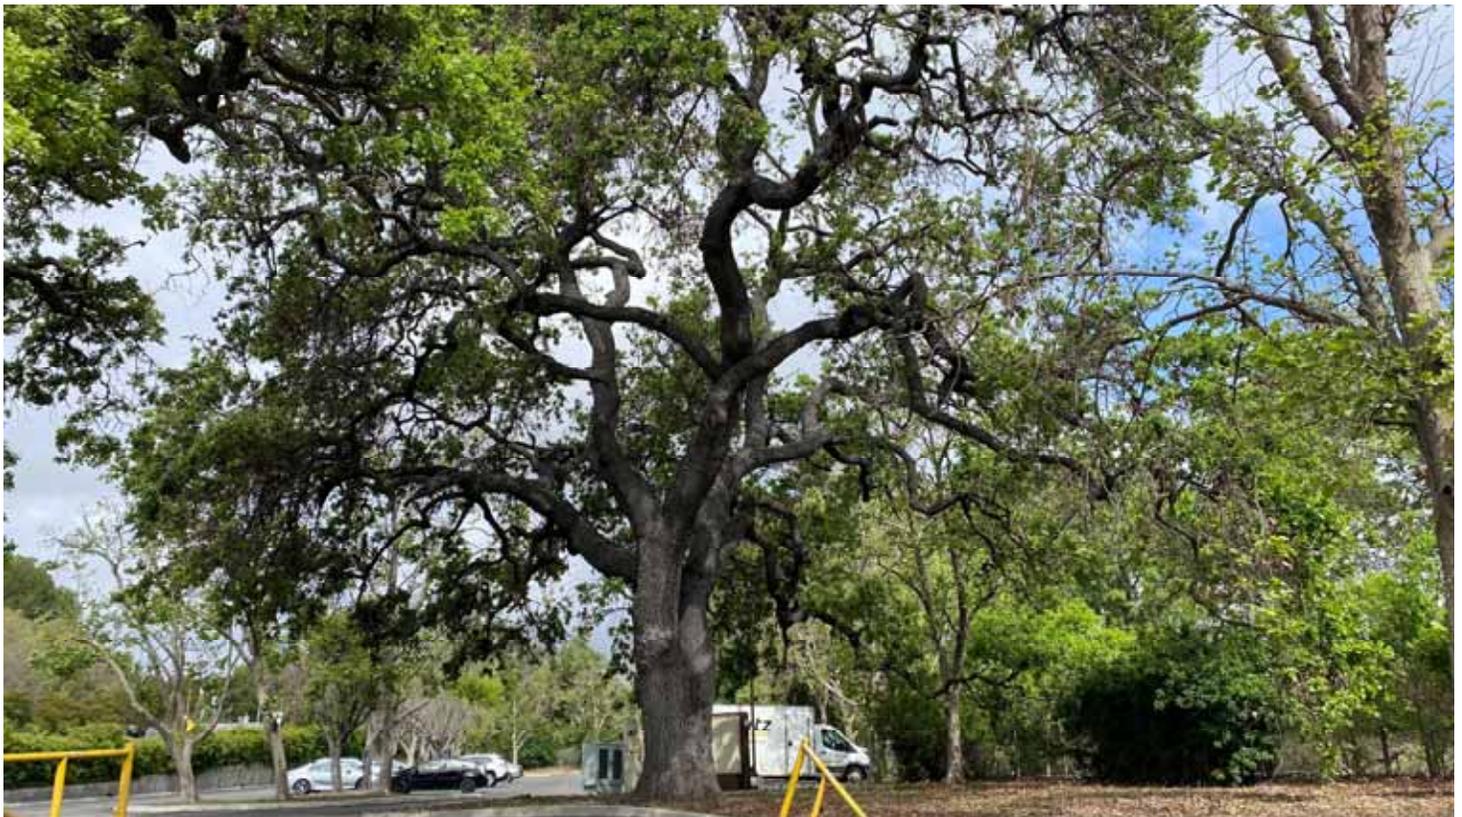
Tree #1 facing north

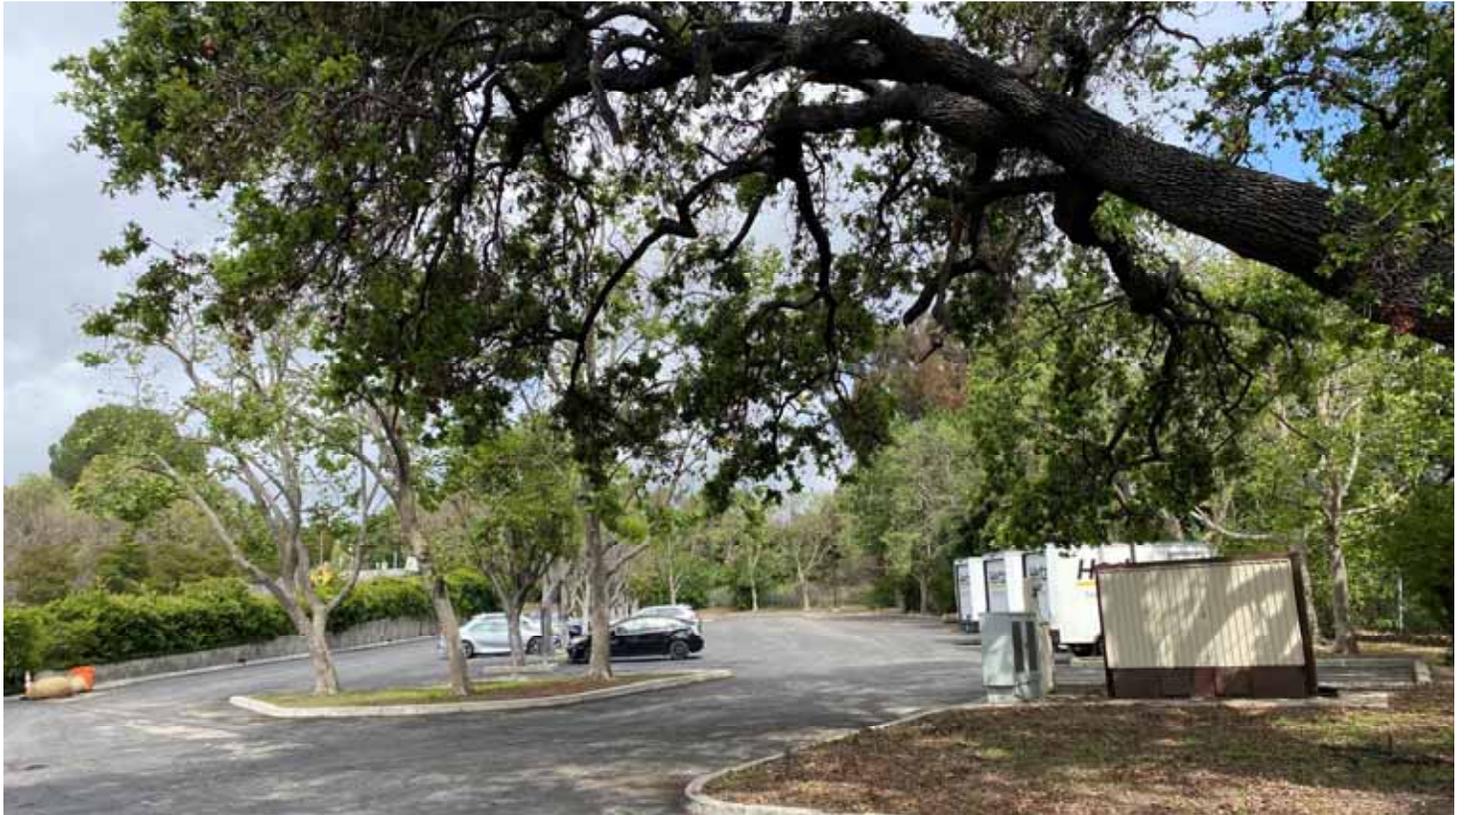
Tree #1 facing north. Clearance pruning to 16 feet over driveway, this part of the tree only.

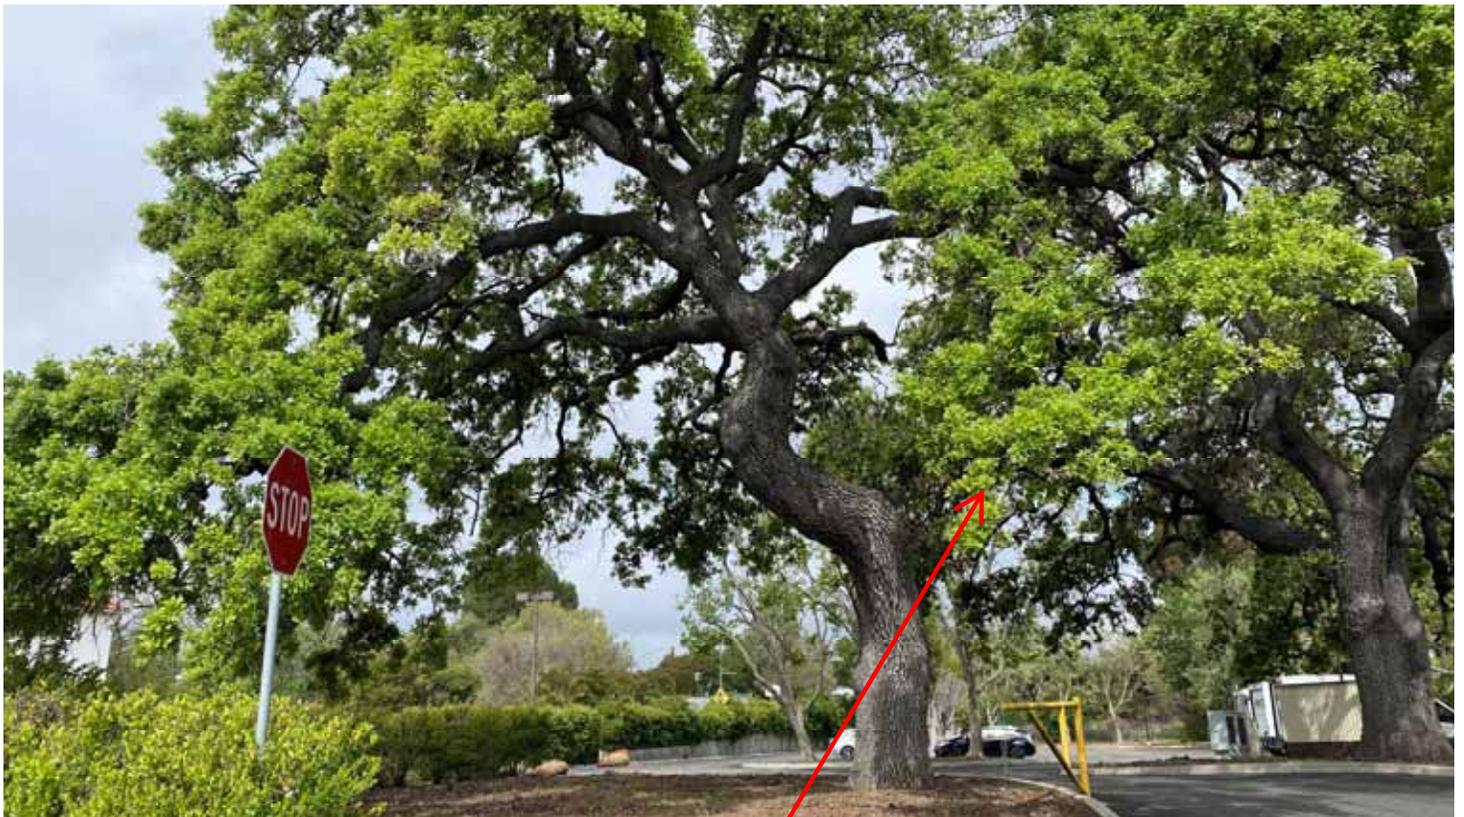
Tree #2 facing north. Clearance pruning to 16 feet over driveway, this part of the tree only.

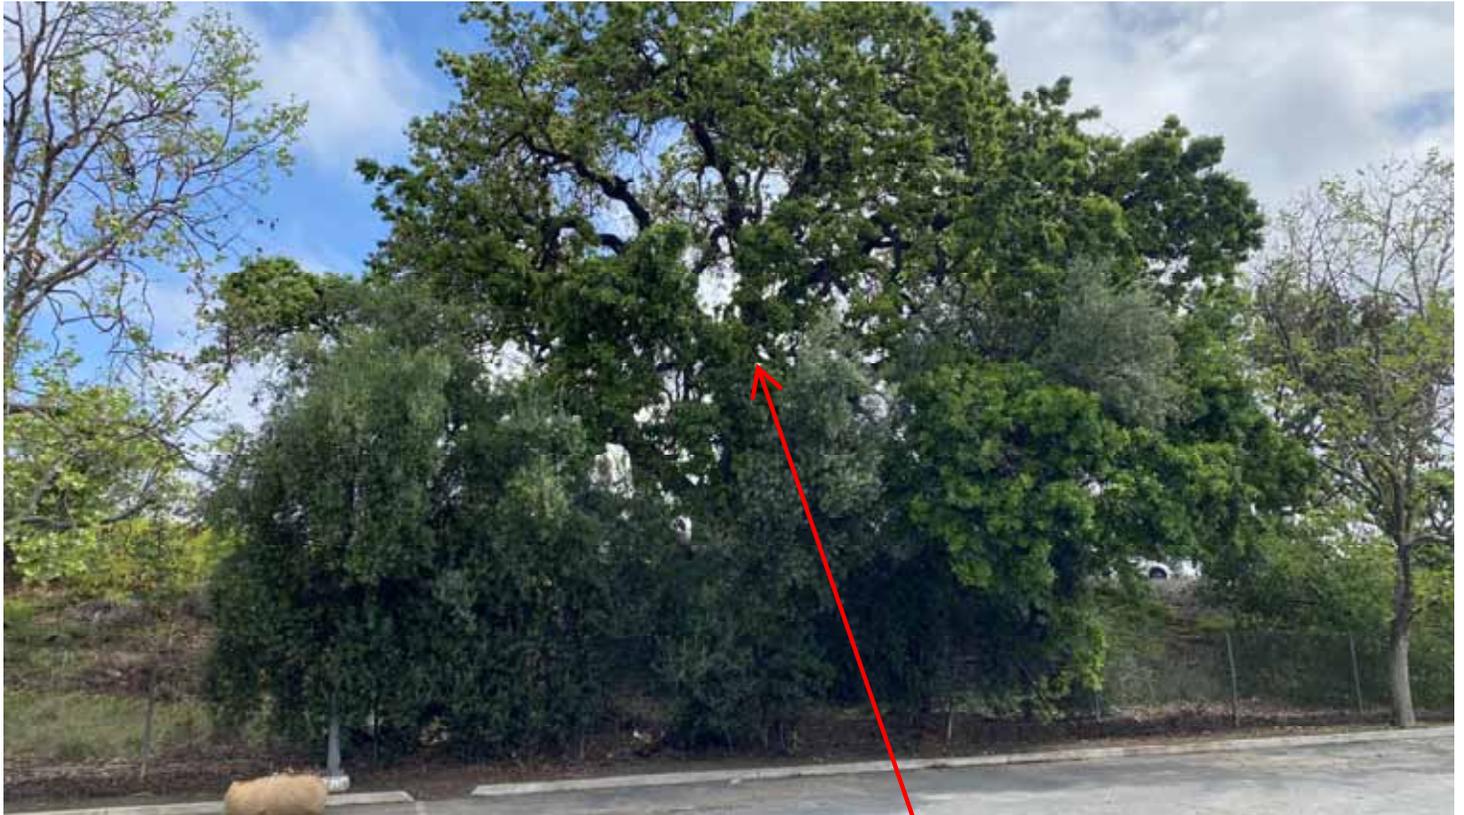
Oak trees #3 and #4 are located off-property and slightly extend over the parking lot. Some live tissue of branches less than 2 inches may need to be pruned for clearance.

Tree #3 facing east. Trunk is located off-property. No pruning.

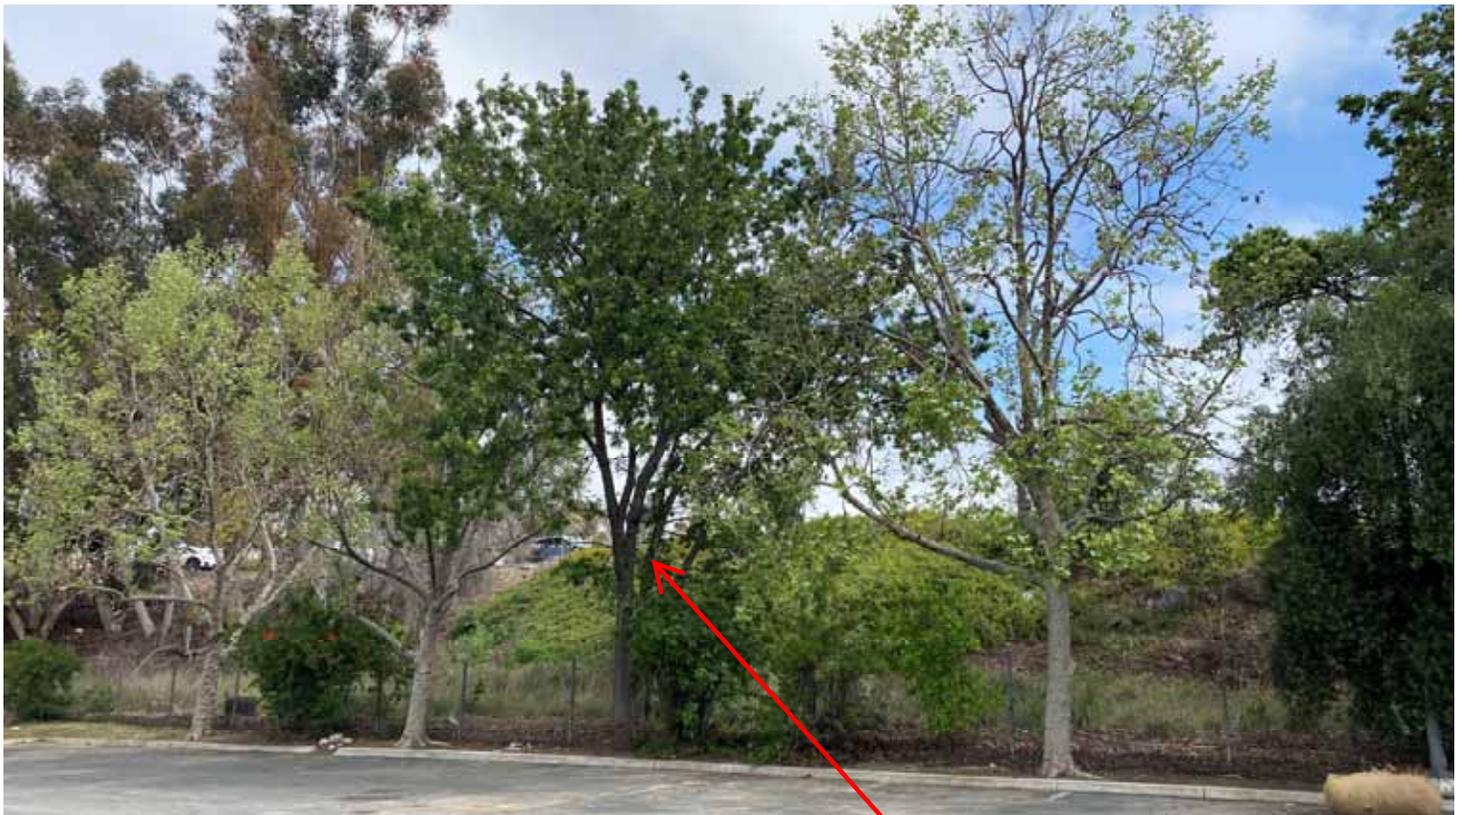
Tree #4 facing north. Trunk is located off-property. No pruning.

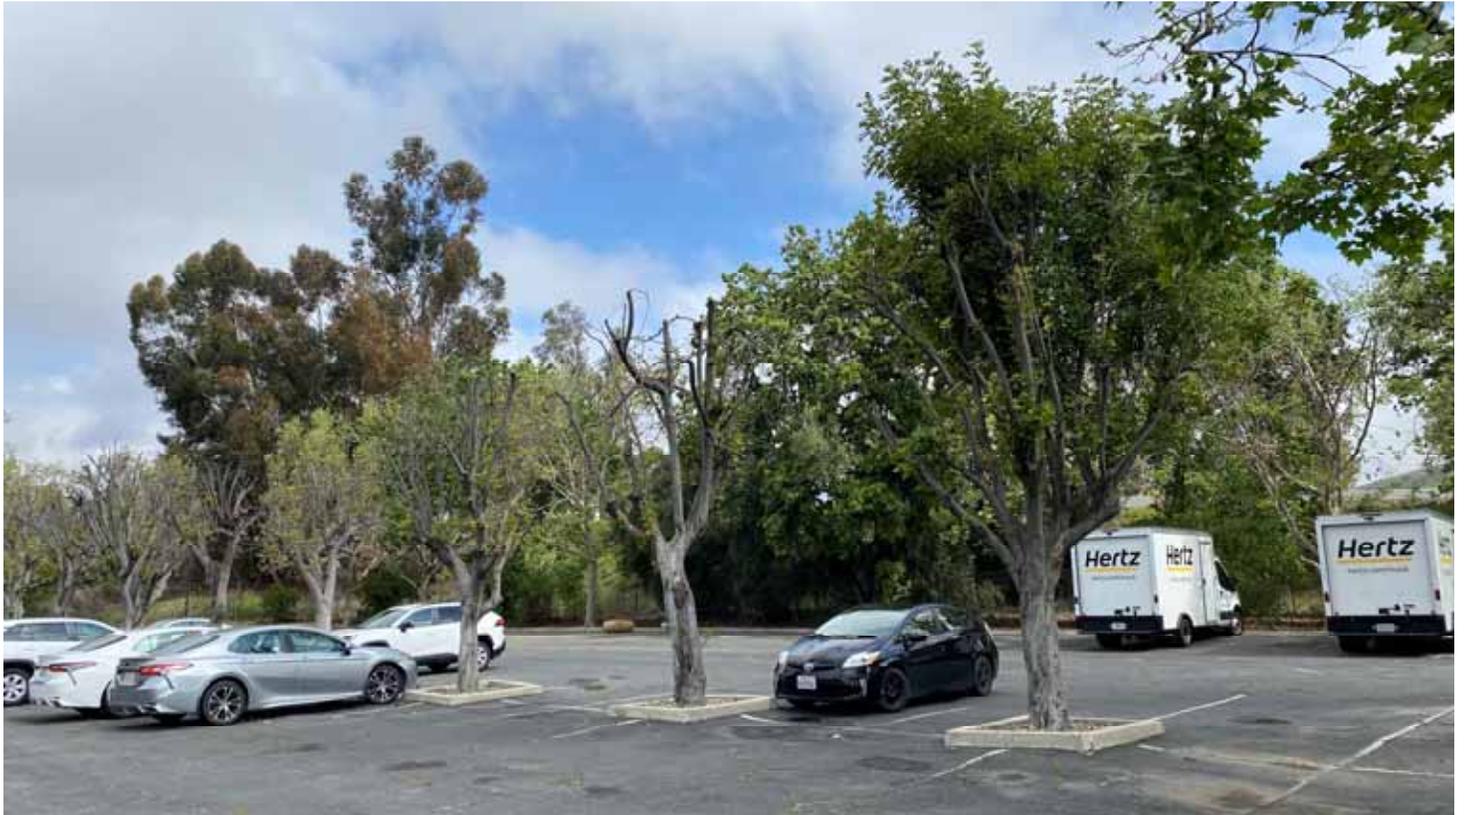
The other 27 trees on this site, planted when the landscape was originally installed, are 16 London plane trees (*Platanus acerifolia*) and 11 carrotwood trees (*Cupaniopsis anacardioides*). 9 of the 11 carrotwoods were ruined by excessive pruning and are not likely to recover to become attractive or healthy trees. 2 of the carrotwoods are proposed to be removed for the project.

Carrotwood trees.

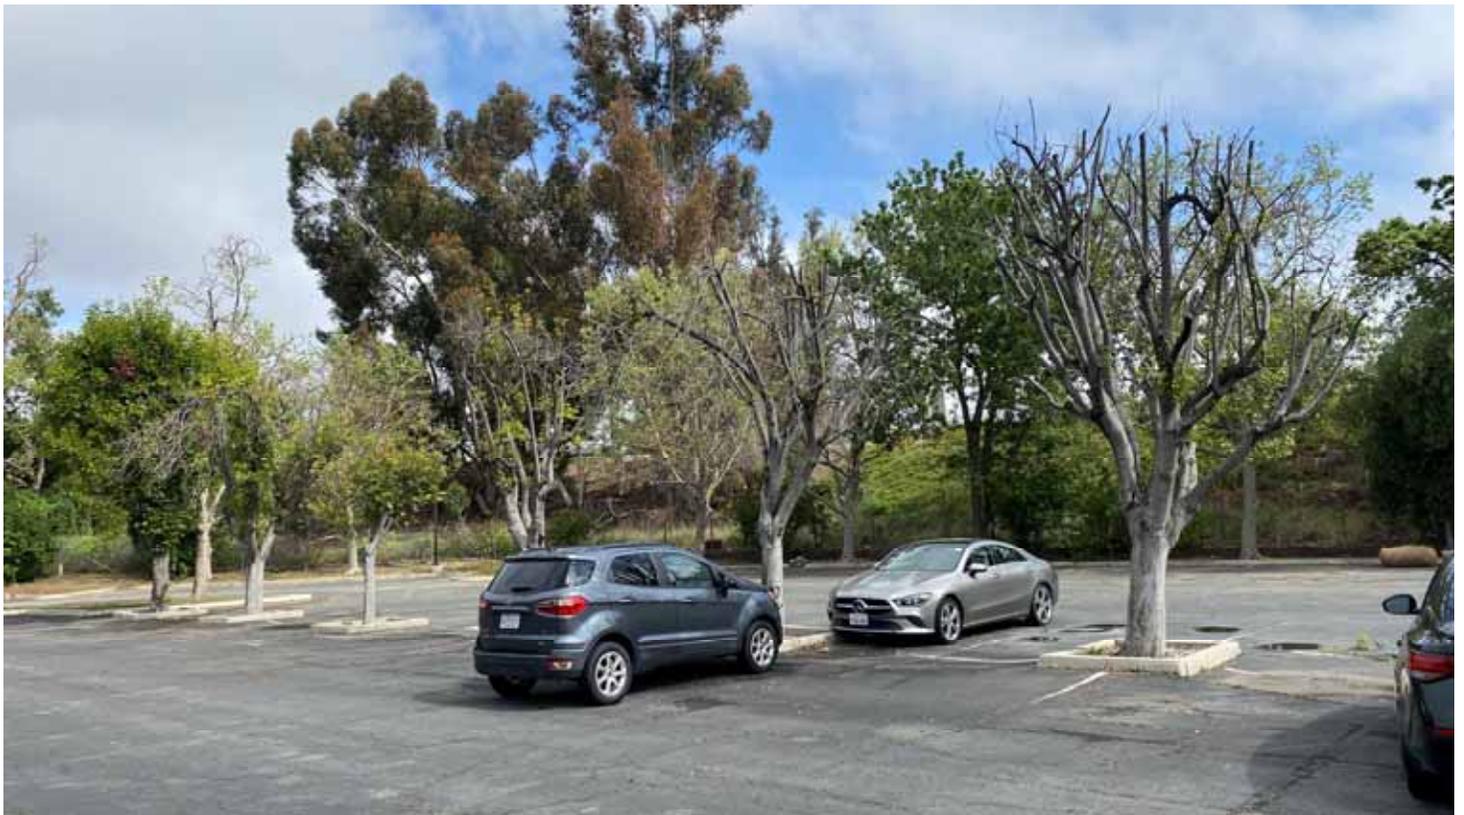
Carrotwood trees.
