OAK TREE REPORT

Latigo Hillcrest
2150 Hillcrest Drive
Newbury Park, Ca 91320-2209

RDI Project No.: 1063-1-21
Original Date: August 23, 2022
1st Revision Date: December 8, 2022
2nd Revision Date: March 27, 2023
3rd Revision Date: May 2, 2023
4th Revision Date: May 4, 2023

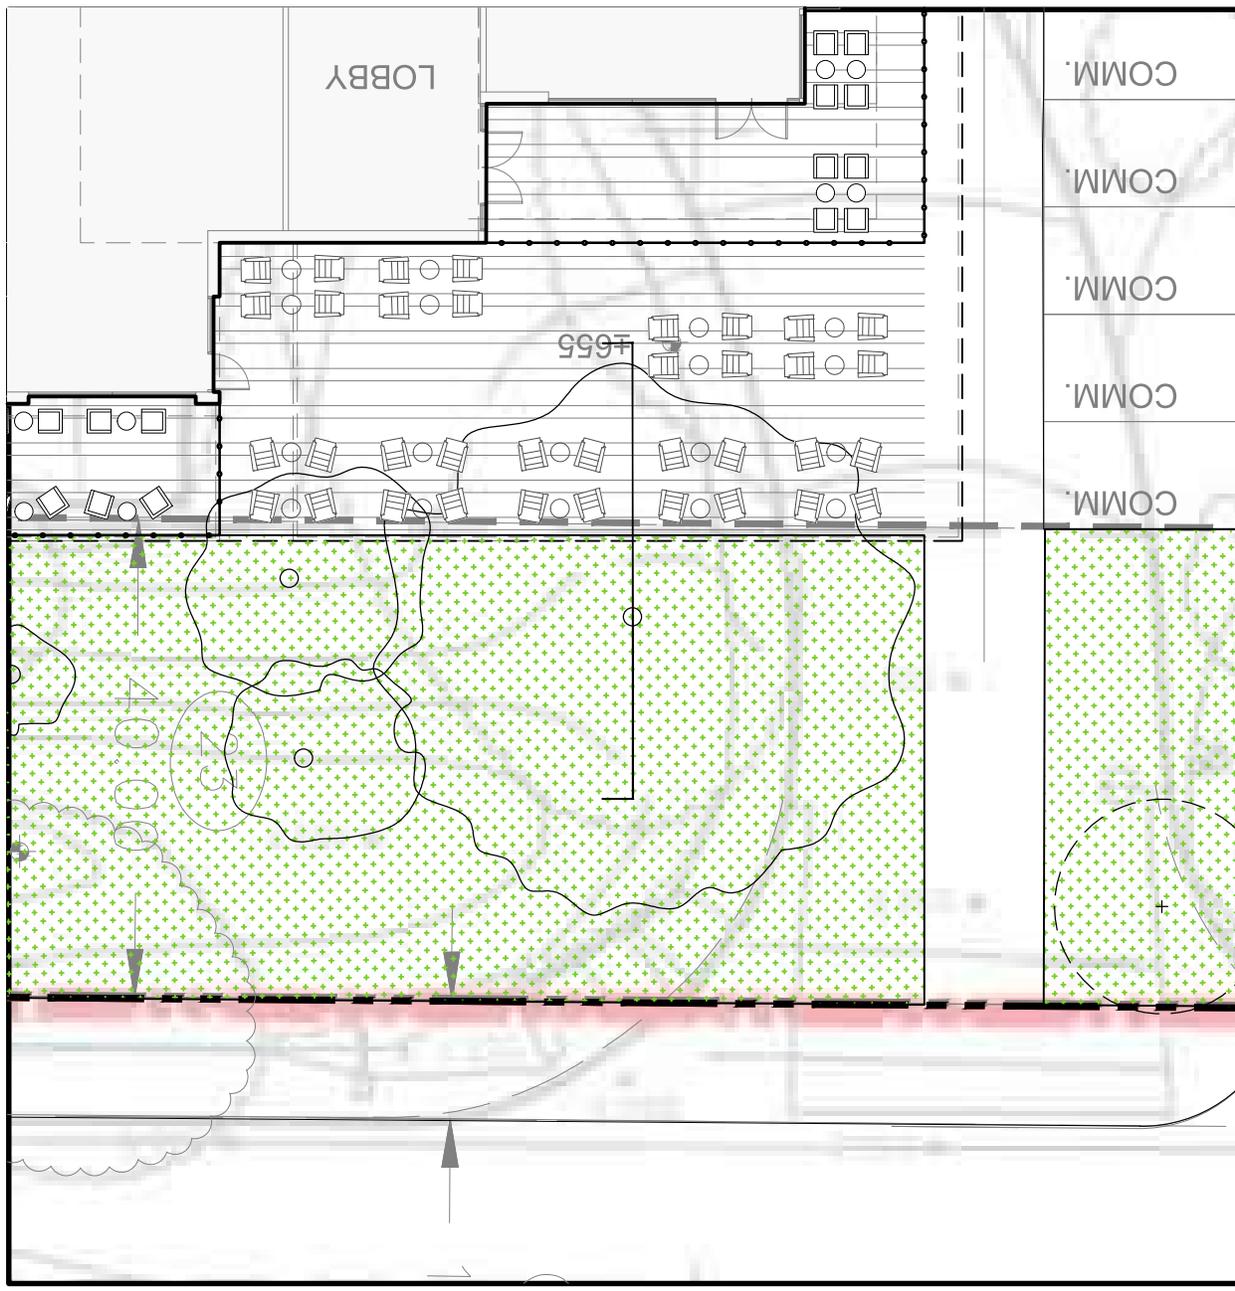
OAK #7

- 7 **SAVE** = this one [1] Coast Live Oak shall remain during & after the construction of this proposed project.

To the west of the tree trunk, an existing sidewalk, curb & driveway currently exists within this tree's drip line, eight [8] feet from the trunk, shall be removed very carefully by hand or very small equipment.

Also to the west of the tree trunk shall be the "limits of fill-grading". This "limits of grading" shall be no closer than twelve [12] feet away.

To the south of the tree, the proposed "Building A" patio-deck area shall be constructed within six & one-half [6½] feet of the trunk. Live wood pruning of the following branches will be required to occur to this Oak for "use clearance" of the patio-deck: one 3" branch, one 4" branch, one 6" branch & one 8" branch.

Also to the south of the tree trunk shall be the "limits of fill-grading". This "limits of grading" shall be no closer than seven [7] feet away.

The removal of the existing & the installation of the proposed drip line encroachments &/or live wood pruning to this tree should pose no future consequences to its longevity.

The overall area of the Protected Zone for this tree takes up 2,335 sq. ft. The existing encroachment for the sidewalk, curb & driveway covers 619 sq. ft. (or 26.51%). The proposed encroachment for the new patio-deck covers 689 sq. ft. (or 29.51%).
