# PROTECTED TREE REPORT

Ms. Tricia Ferruzza

3948 Skelton Canyon Circle  
Westlake Village, CA 91362

James Dean, RLA

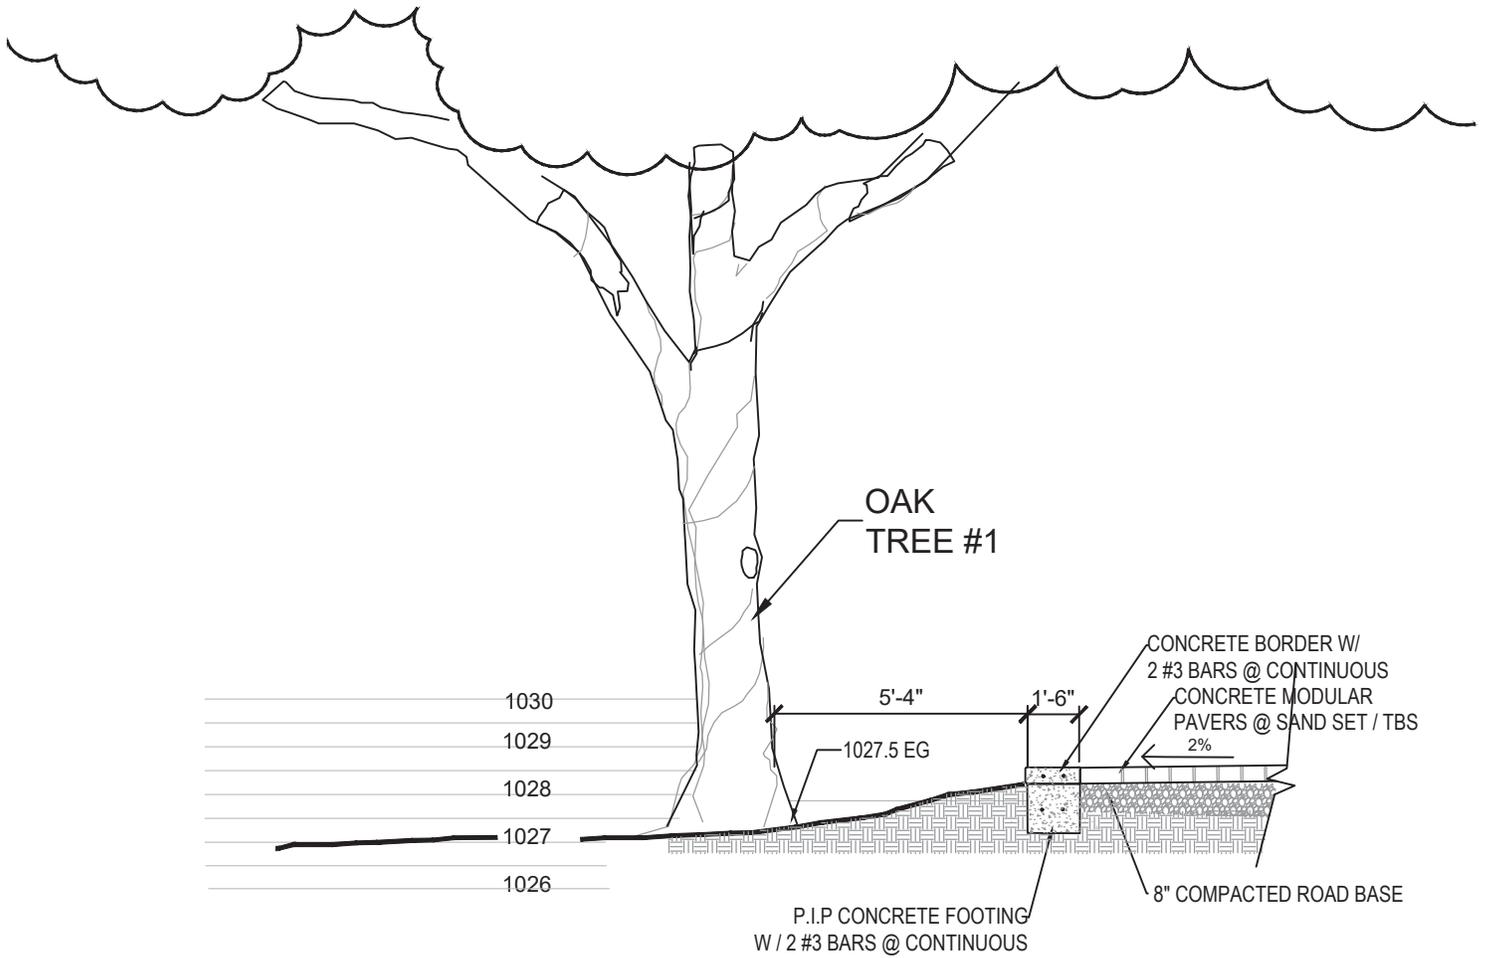
# TREE NO. 1

The entrance driveway will pass Tree No. 1 with the edge of the wall. The driveway surface will be constructed of pervious pavers. The driveway will be approximately five (5) feet from the tree trunk. The resulting impact, from utility excavation, will occur eleven (11) feet from the tree trunk. The vertical placement, and excavation for each utility will vary. The low wall and concrete curb, on this side of the drive, will be heavily reinforced with steel bars to prevent future damage from expanding roots.

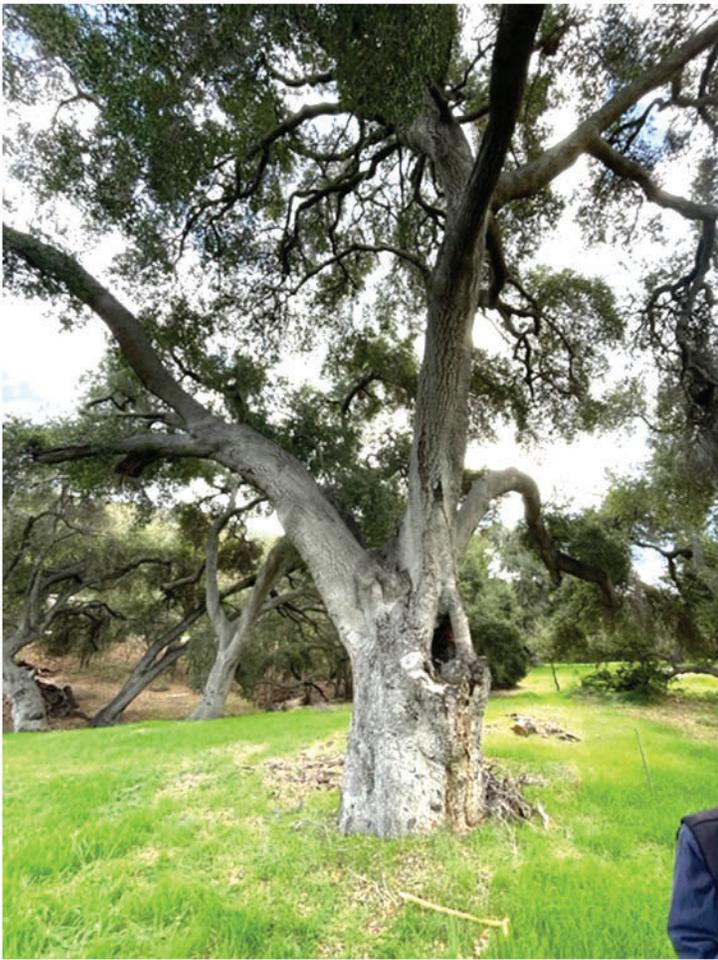
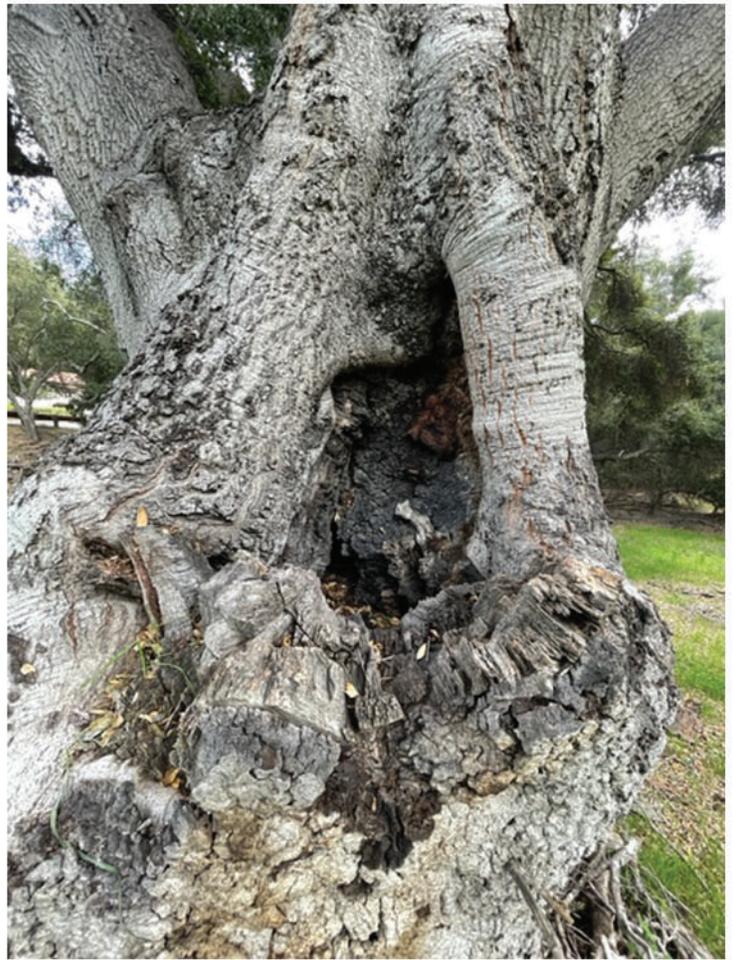
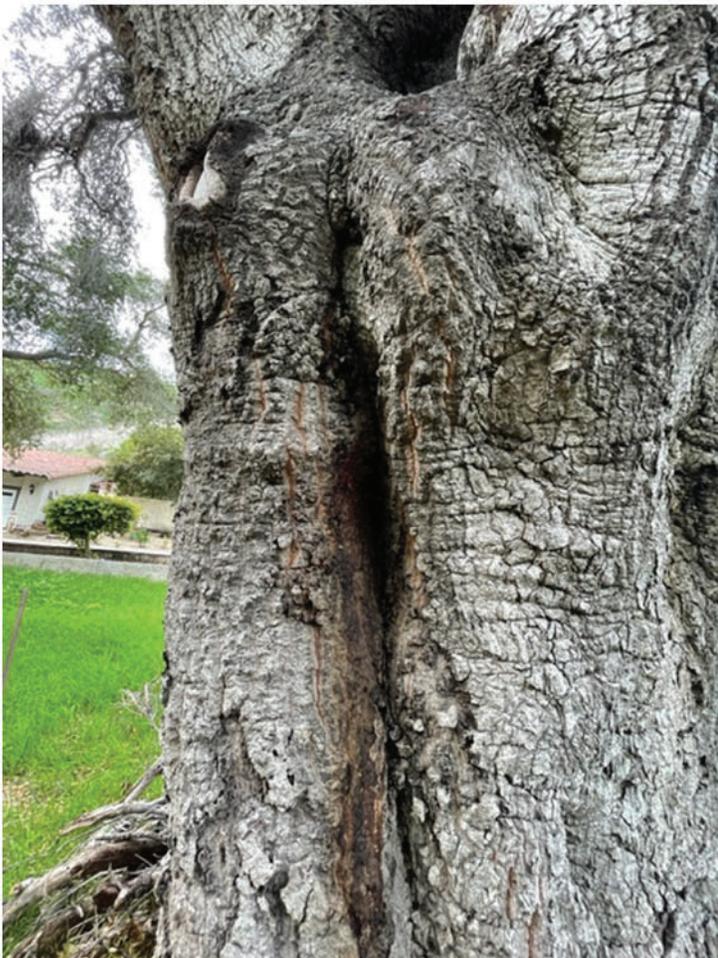
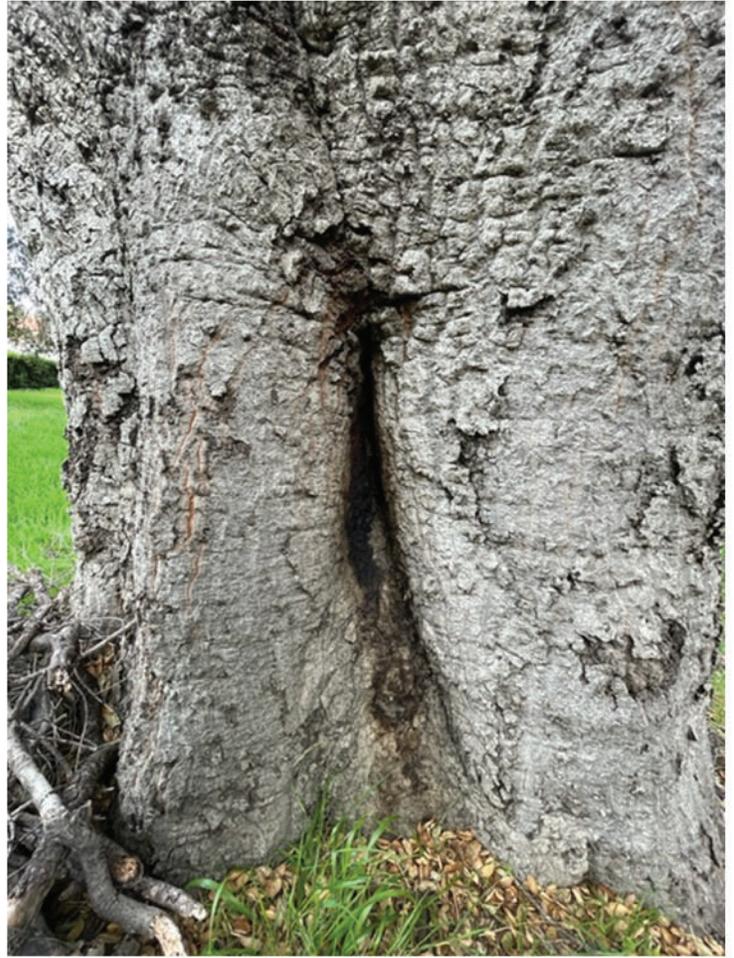
TREE 1

TREE NO. 1 (tagged) Off-Site  
This tree is Heritage size and presents a hazard of failure.

Additionally, a significant broken branch wound can be seen, high on the east side of the tree leaving a ragged tear visible. Another branch has fallen to the south of the tree. These branches should be appropriately pruned.

On the north-west side of the tree, near the ground, there is another very large open cavity that will be visible, resulting from past branch failure. It begins approximately 5' above grade, extending vertically for eight (8) feet and has a width of two (2) feet. This wound displays major decay and dead wood extending beyond the cavity. Looking into the cavity one can see the central bole of the tree is missing, having been consumed by saprophytes. Also, on the south side, a lesion is present. It travels from grade, upward two and one half (2.5) feet. It is approximately 8" wide. This lesion also has visible rot and exudation. Considering the degree of rot in the bole of this tree it presents a significant risk of failure in the future. HOA should be notified.

The wounds that have occurred from the branch failures, should be treated in the following way:

1. Clean the wound margin of dead tissue and loose debris.
2. Where possible remove the dead wood extending out of the open cavity.
3. In doing so, avoid creating any new wound, thus preparing the wound for natural closure over time.
4. Tack a sheet of small wire mesh to enclose the cavity preventing the collection of leaf matter into it.

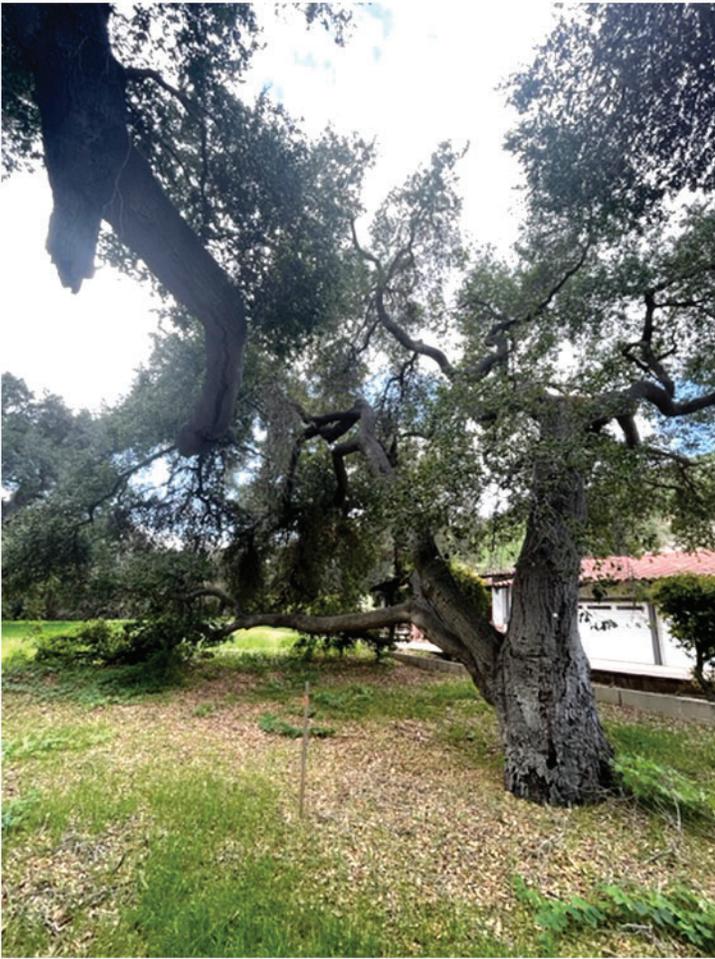
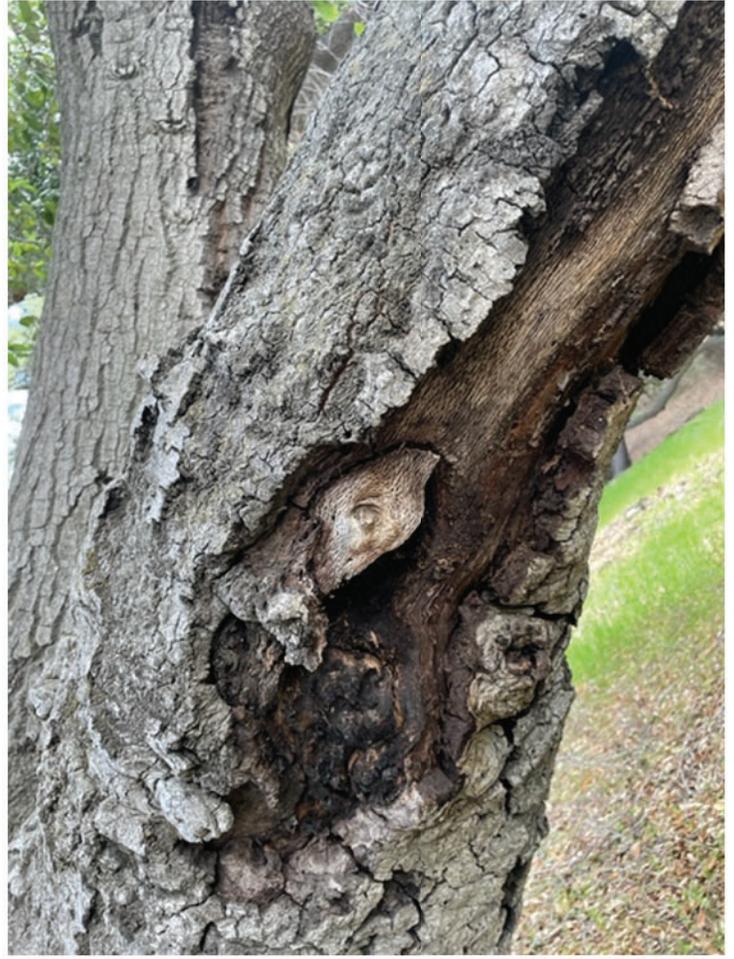
TREE 2

DESCRIPTION:  
Tree No.2, a mature specimen of the species. It presents a high level of vigor with abundant yearly growth extension. Low scaffold branches extend in a south-east direction with the branch growth and the leaf skirt extending downward to natural grade preventing through access for the driveway. The bark of one branch on the southwest side is exfoliating from a continuous lesion with rot underneath.

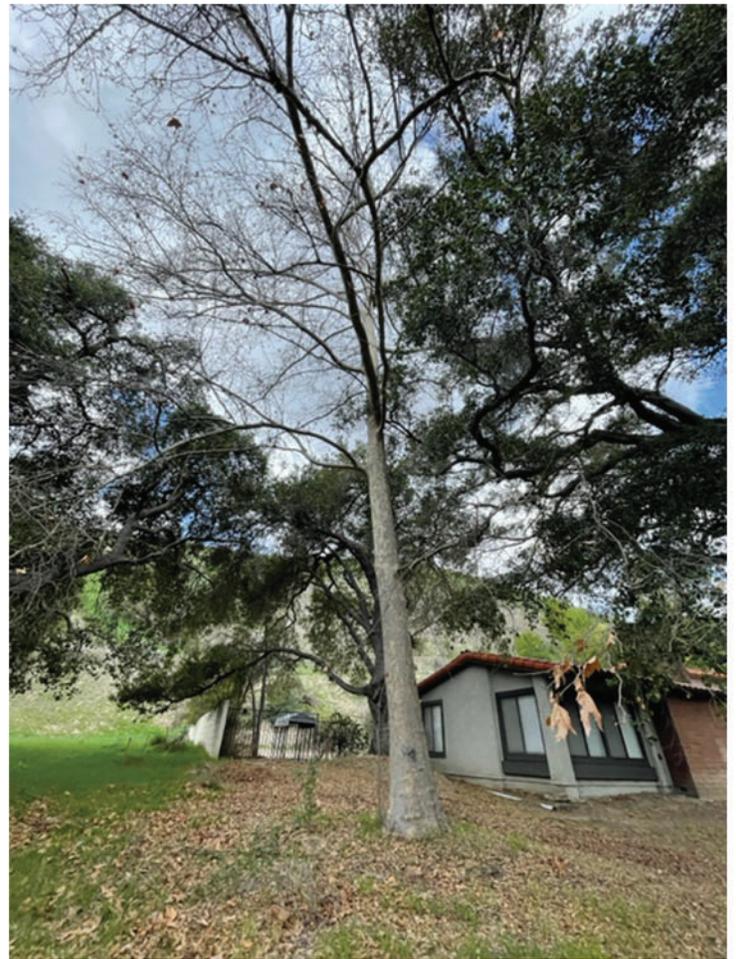
OFF SITE - TREE 233 & 233a behind it

Tree No. 233 appears healthy and vigorous however, it is deciduous at this time preventing evaluation of its condition. It displays a single trunk standing vertical, and features a high branching structure with some very small branches that descend over the driveway blending with tree No.7.

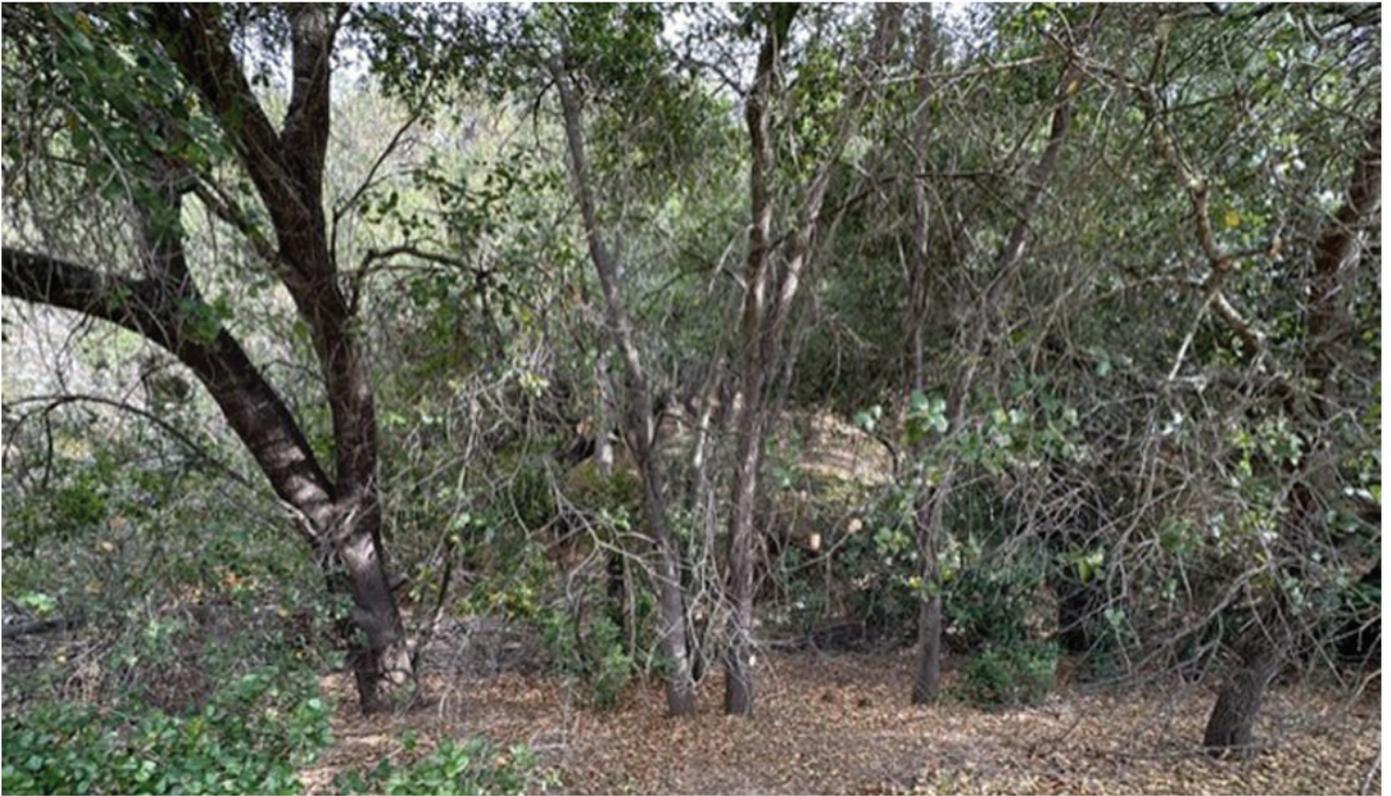
TREES 51A - 51G NOT TAGGED

Seven (7) immature (immature) Coast Live Oak trees were surveyed and added to the inventory as shown on the map. They are present between Trees 51 and 53 and are assigned numbers 51A-G. They were not tagged due to the precipitous and dangerous slope condition.

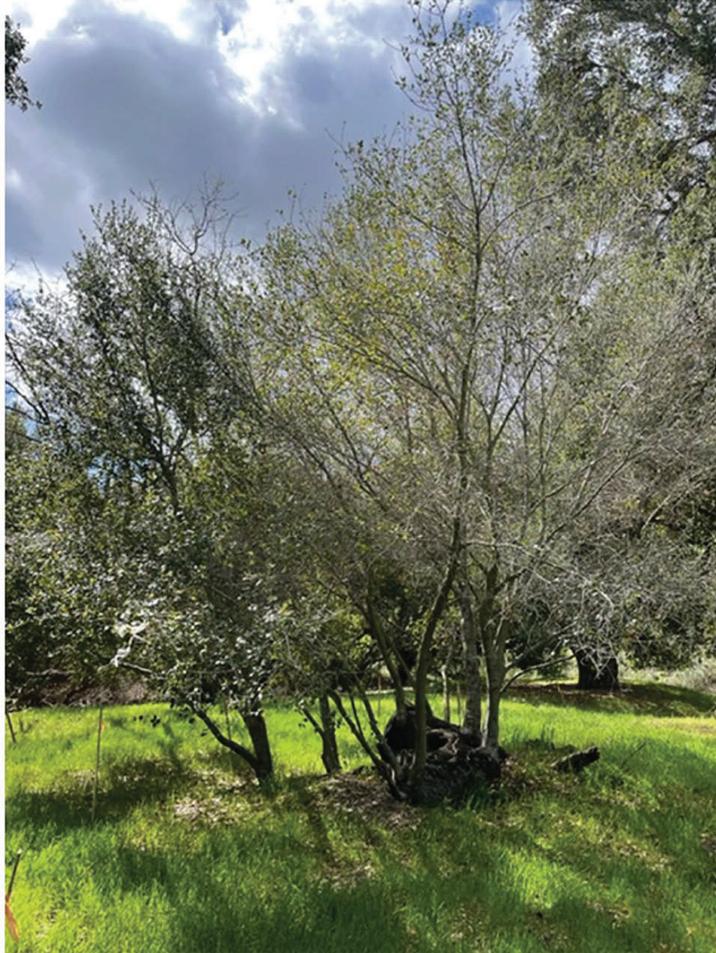
TREE 4

Tree No. 4 is the stump of an old specimen tree resulting from its past failure. It displays several small volunteer trunks that are dead, and several live trunks alive that are regenerating from the old tree.

A very large Valley Oak, on the neighboring site failed, landing partly upon the Ferruzza site, causing damage to this tree. The damage to the Ferruzza tree occurred to the dead stumps protruding directly from the old tree root crown. The fallen tree has been removed.

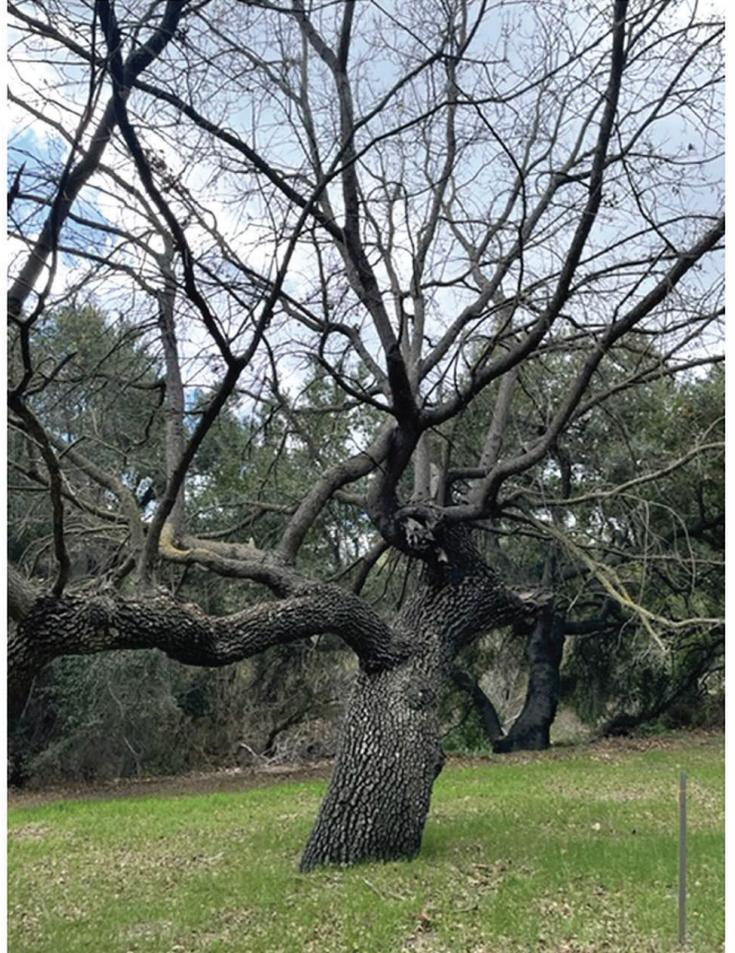
TREE 232

DESCRIPTION:  
Tree No. 232 is a mature specimen of the species presenting a high level of vigor, with abundant new yearly growth extension. There are two broken branch stubs, with significant rot visible. Low scaffold branches extend in a northeasterly direction, interfering with the driveway, and will require pruning for vehicle clearance.

A large old pruning wound is located high on the south side of the trunk. It measures approximately two-foot (2) across a circular area. Surficial woodpecker damage is present along with significant dead wood.
