# PROTECTED TREE REPORT

Ms. Tricia Ferruzza

3948 Skelton Canyon Circle  
Westlake Village, CA 91362

James Dean, RLA

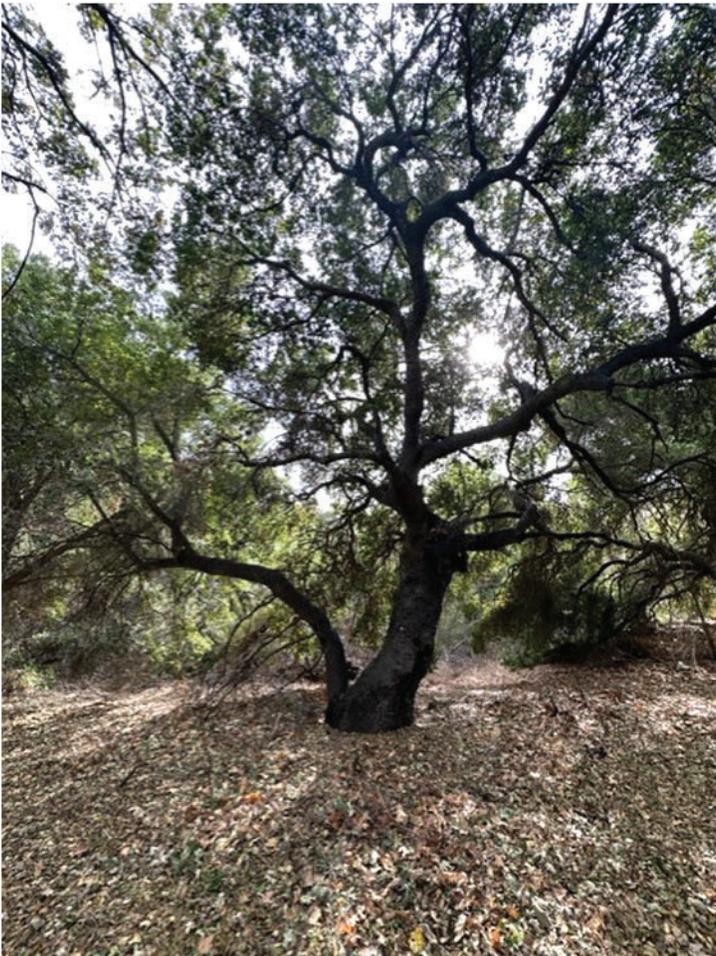
TREES 51A - 51G NOT TAGGED

Seven (7) immature (immature) Coast Live Oak trees were surveyed and added to the inventory as shown on the map. They are present between Trees 51 and 53 and are assigned numbers 51A-G. They were not tagged due to the precipitous and dangerous slope condition.
